ICF TECHNOLOGY INCORPORATED

Site Name: Autek Systems Corporation

ENVIRONMENTAL PRIORITIES INITIATIVE PRELIMINARY ASSESSMENT

SITE: Autek Systems Corporation

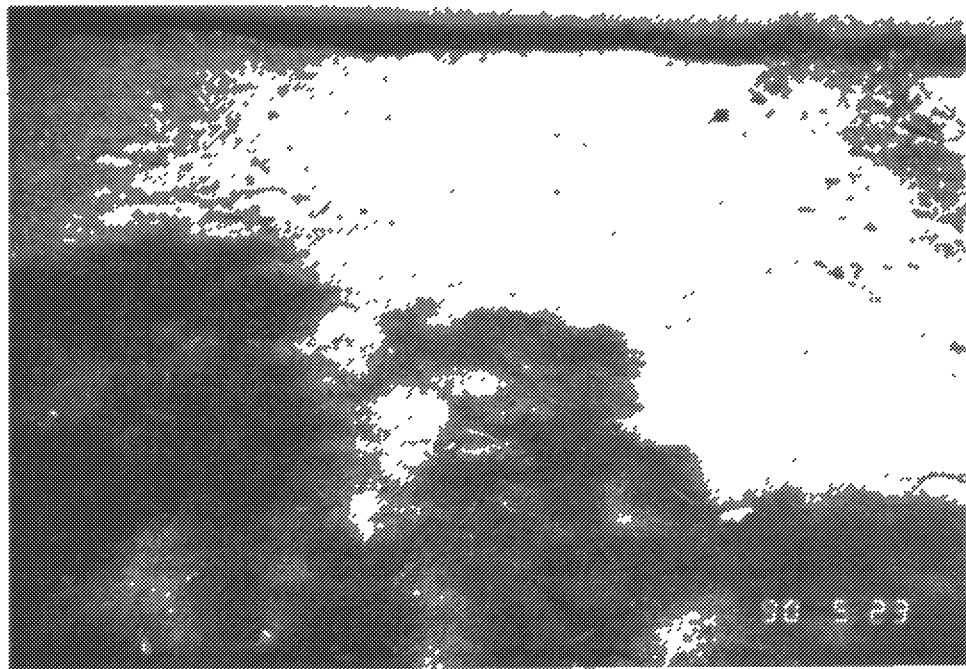
Photo 1: Former underground wastewater neutralization sump area. Pictured is the new soil which was used to fill the pit left by sump excavation. View is facing west.

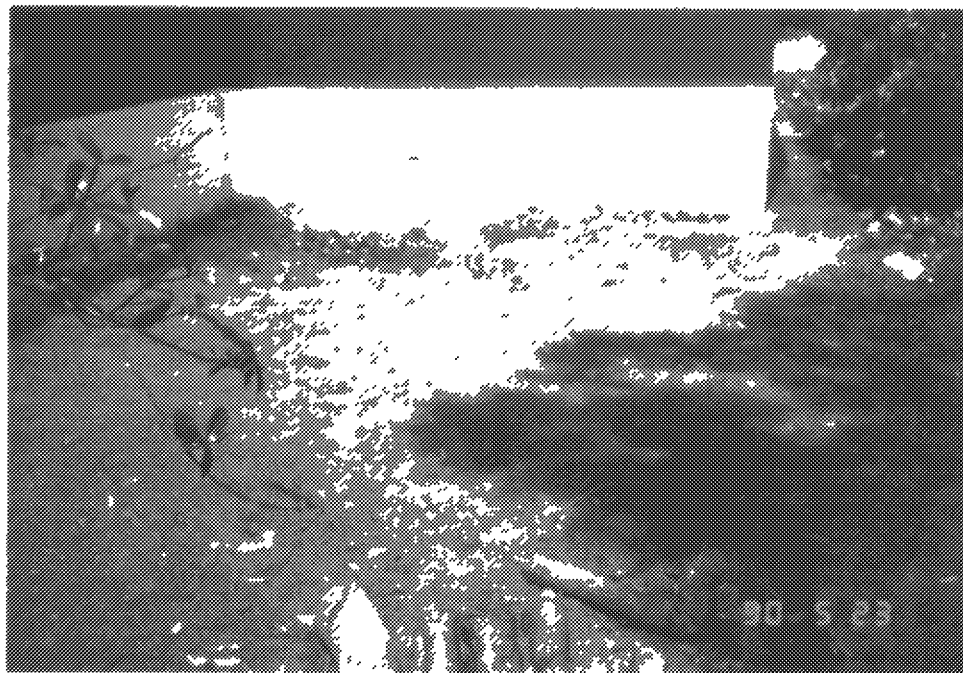
Photo 2: Former underground wastewater neutralization sump area. View facing north.

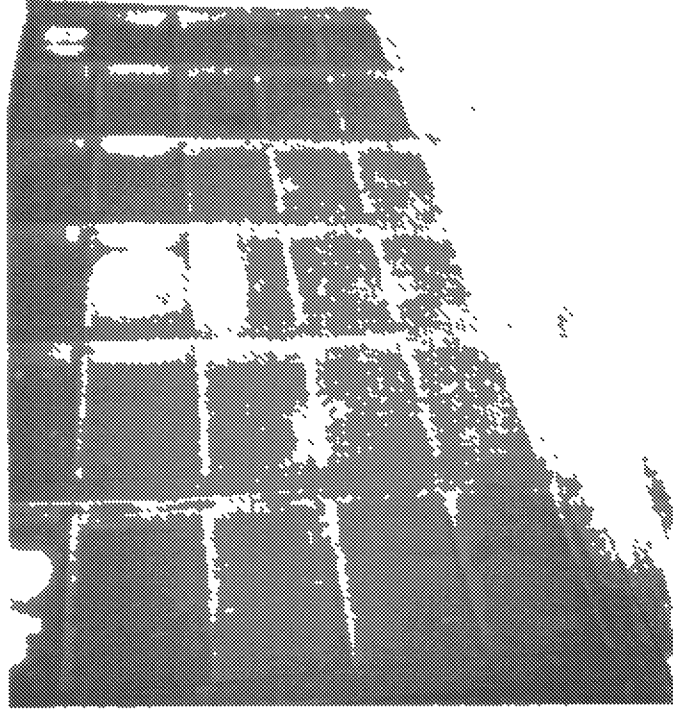
Photo 4: Former location of chemical storage area. Dumpster pictured
currently covers about half of the former area. View facing
northwest.

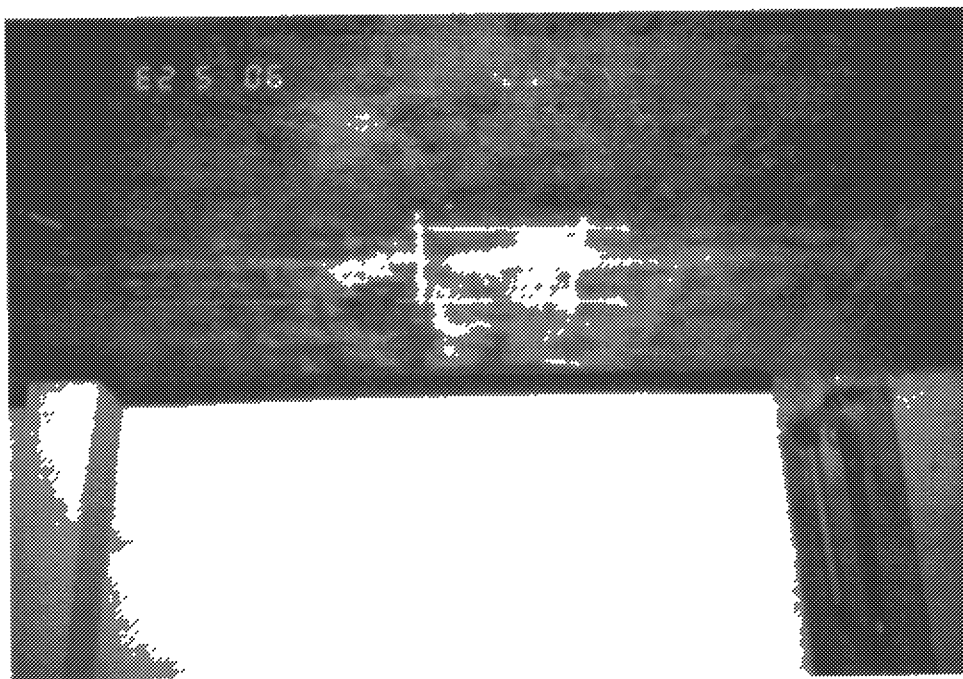
During the facility closure activities conducted in March 1990, the feeder pipe leading to the on-site wastewater neutralization sump was found to be corroded. A soil sample taken from under the feeder pipe from a depth of 1 foot revealed elevated levels of copper (360 mg/kg), cyanide (0.2 mg/kg), fluoride (77 mg/kg), lead (850 mg/kg), and nickel (460 mg/kg) in the soil underlying the feeder pipe (16,31). Background levels and detection limits for the sampling were not listed in the sampling reports submitted to Autek. Tests for boron were conducted and the sampling report indicated that concentrations of boron (if extant) were below 50 mg/kg, however it is not known whether or not that level was below detection limits. Autek representatives did not know how long the feeder pipe had been corroded nor how much of the underlying soil had been contaminated (7). However, during the facility closure activities, 175 cubic feet of materials, including the volume of the wastewater neutralization sump and an unknown amount of soil was reportedly removed from the area of the former sump (20). Based on this information, FIT estimates that approximately 15 cubic feet of soil were removed during the excavation activities (10,20). The excavation was overseen by the City of San Jose Fire Department (7). Based on a review of the soil sampling results, DHS did not request any further excavation or removal of soil (38).

Photo 5: Drainage from floor to feeder pipe to former sump. View facing southeast.

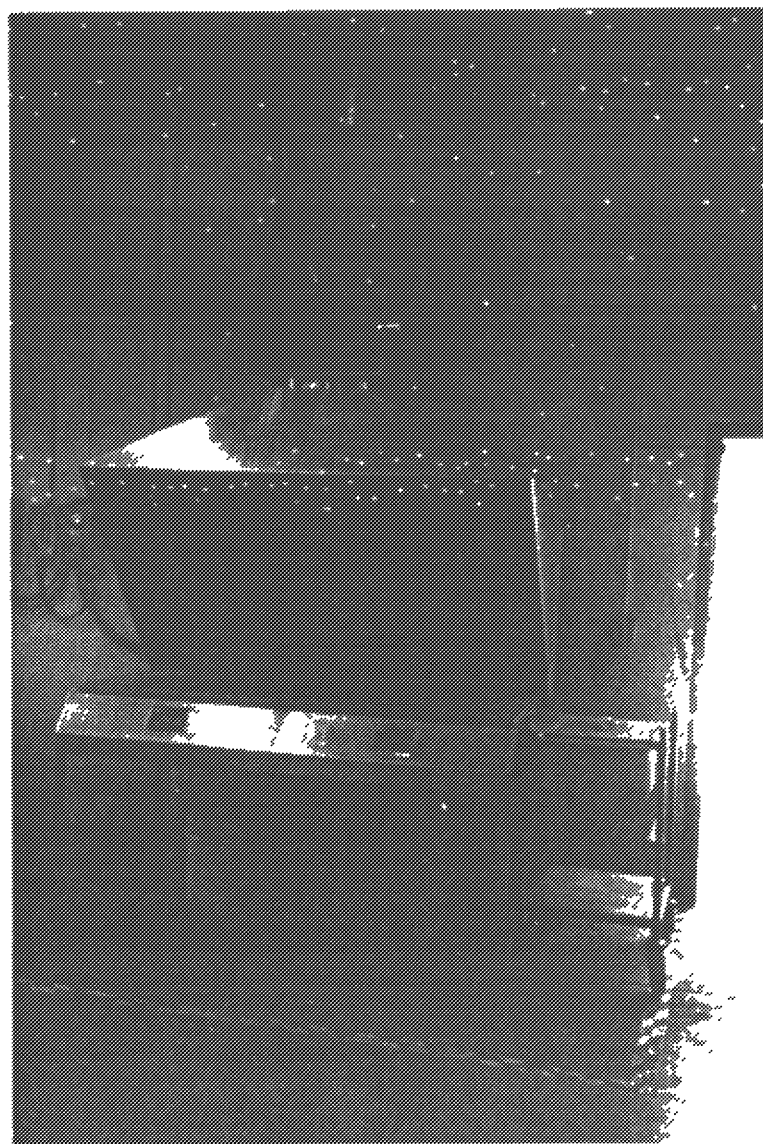
Photo 6: Hot Oil Reflow Department where the temperature in the oven reaches 400°F. The oven is used to fuse the circuit board templates together. Drums of fuel oil were on the left (photo

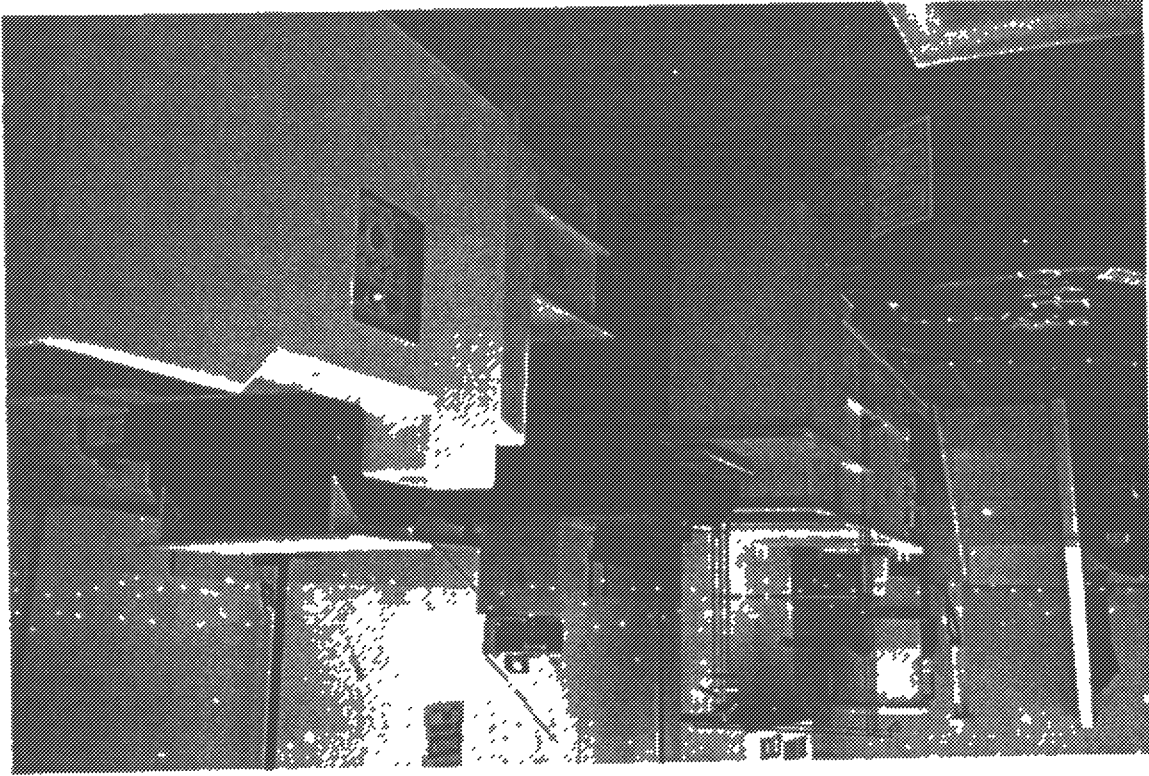
Photo 7: Autok employee pumping contaminated plating bath solution into a 55 gallon drum in the Wet Room. The drum will be placed in the termed hazardous waste storage area in background.

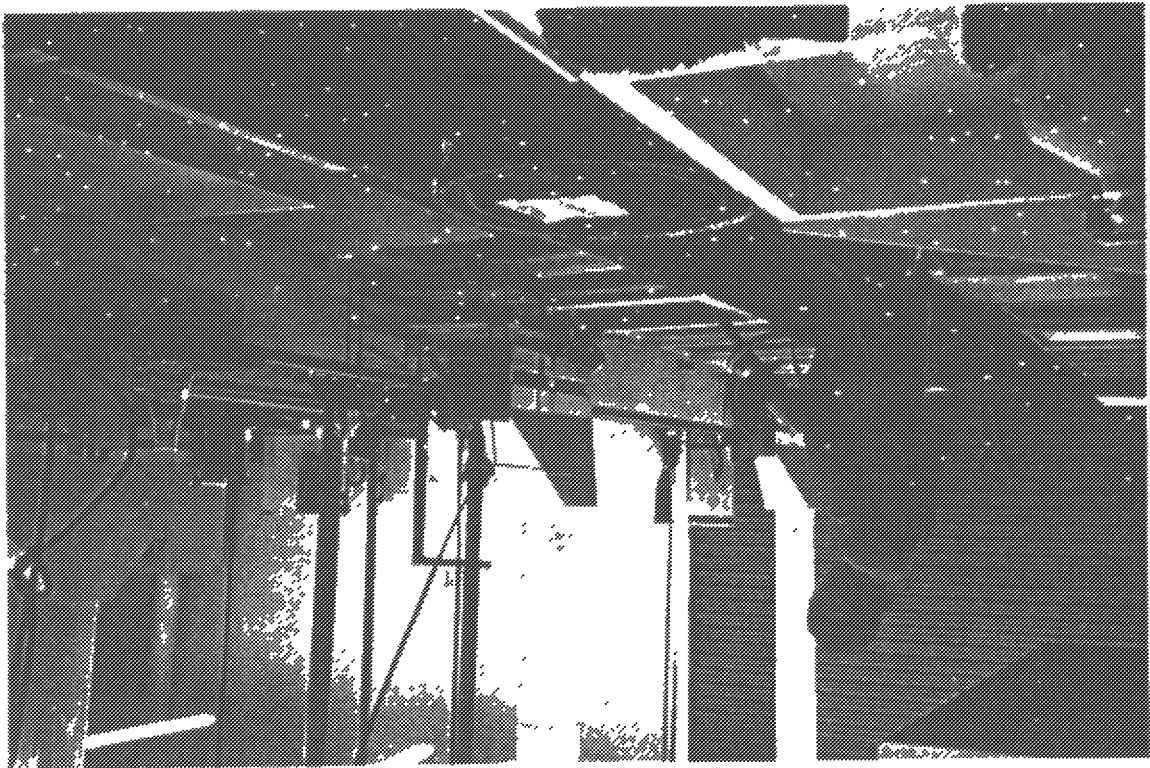
Photo 8: Drum of waste scrubber water from the white tank on the right. Drum is in safe area. accumulation since June 15, 1989.

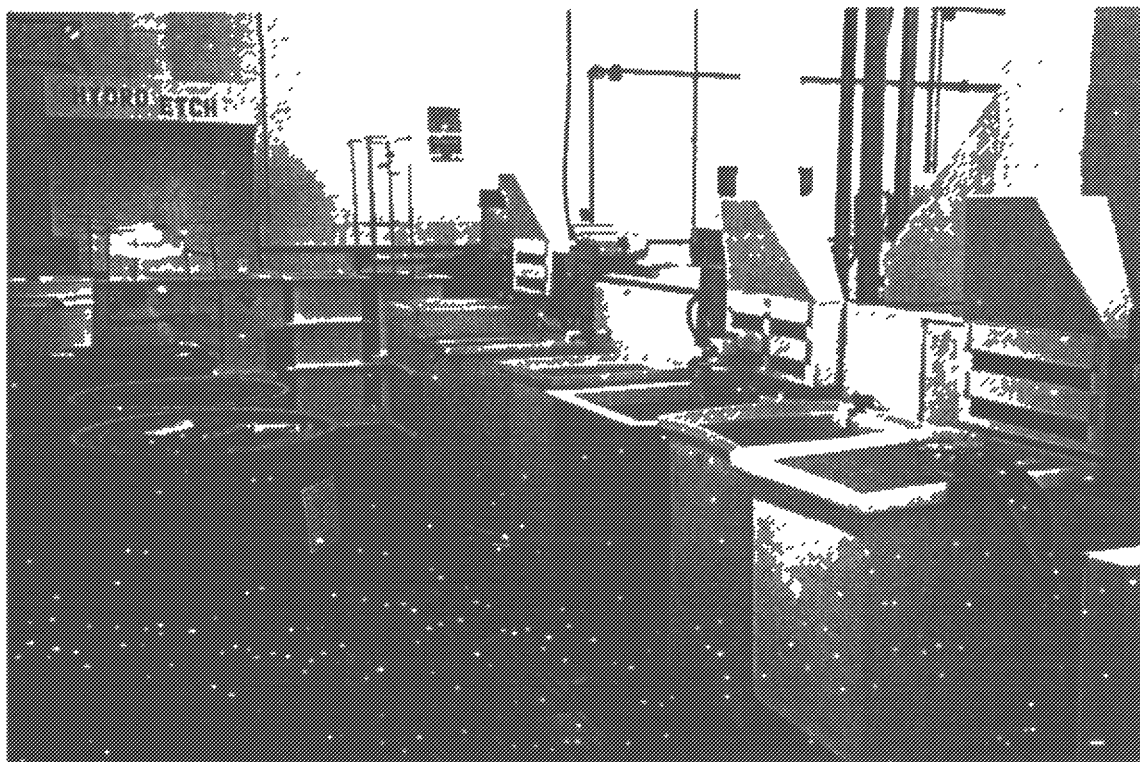
Photo 9: The blue drum with the hazardous waste label is in satellite accumulation. It contains brown oxide drag waste from the white tank on the right.

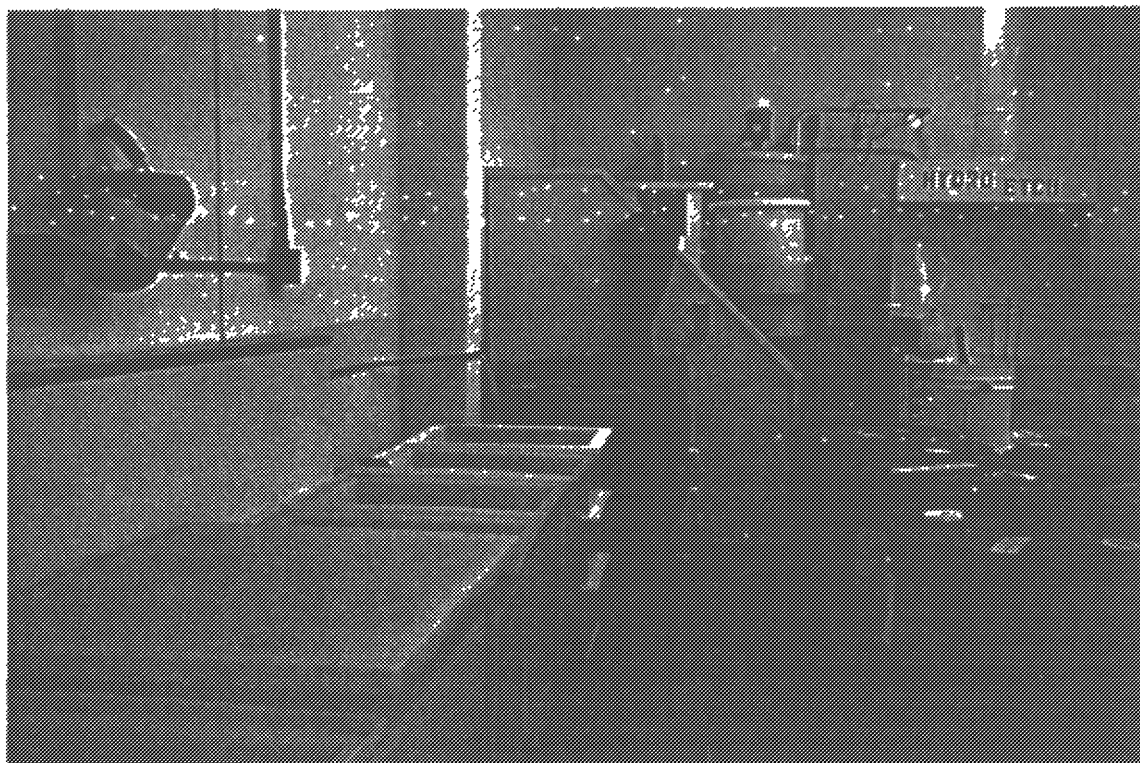
Photo 10: The black drum contains waste concentrated sulfuric acid from the white, covered tank. This drum is in satellite accumulation in the wet room.

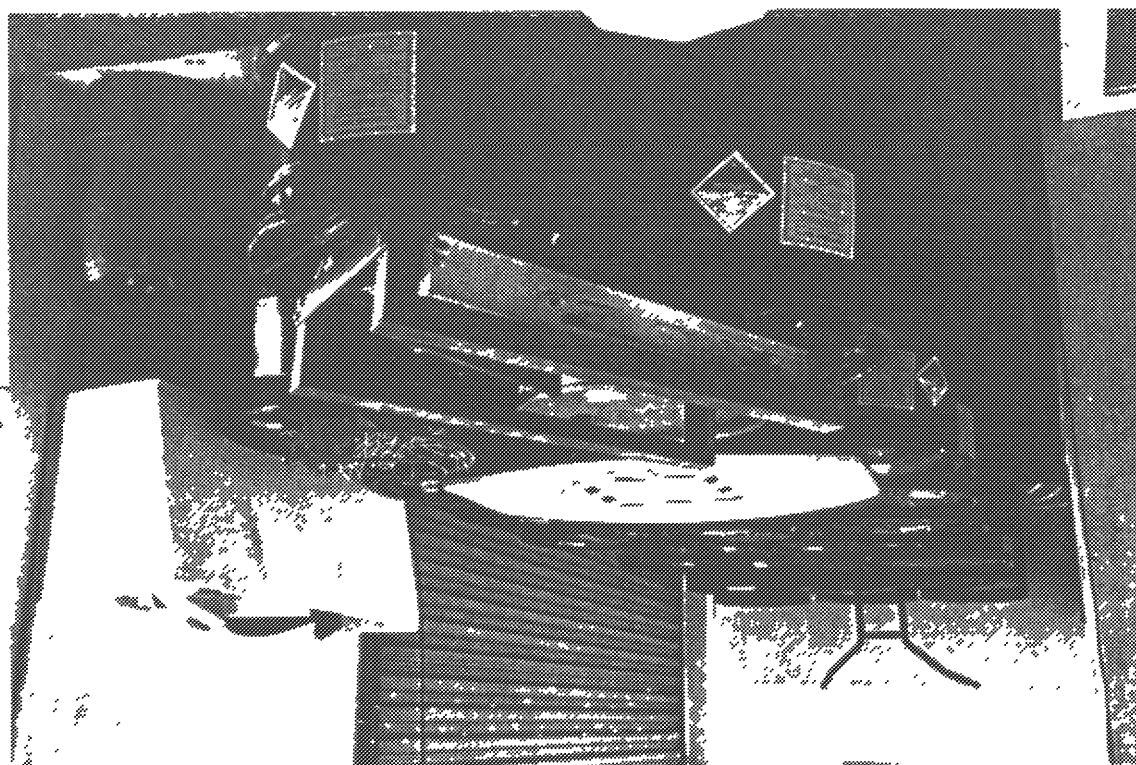
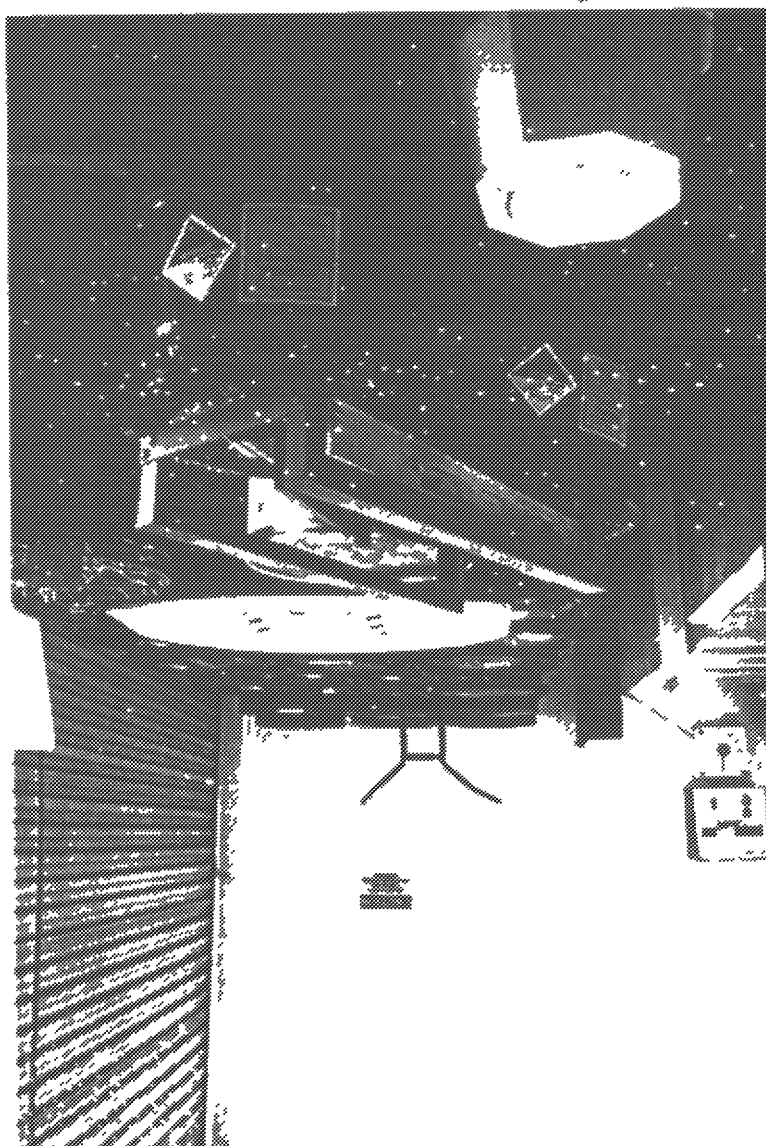
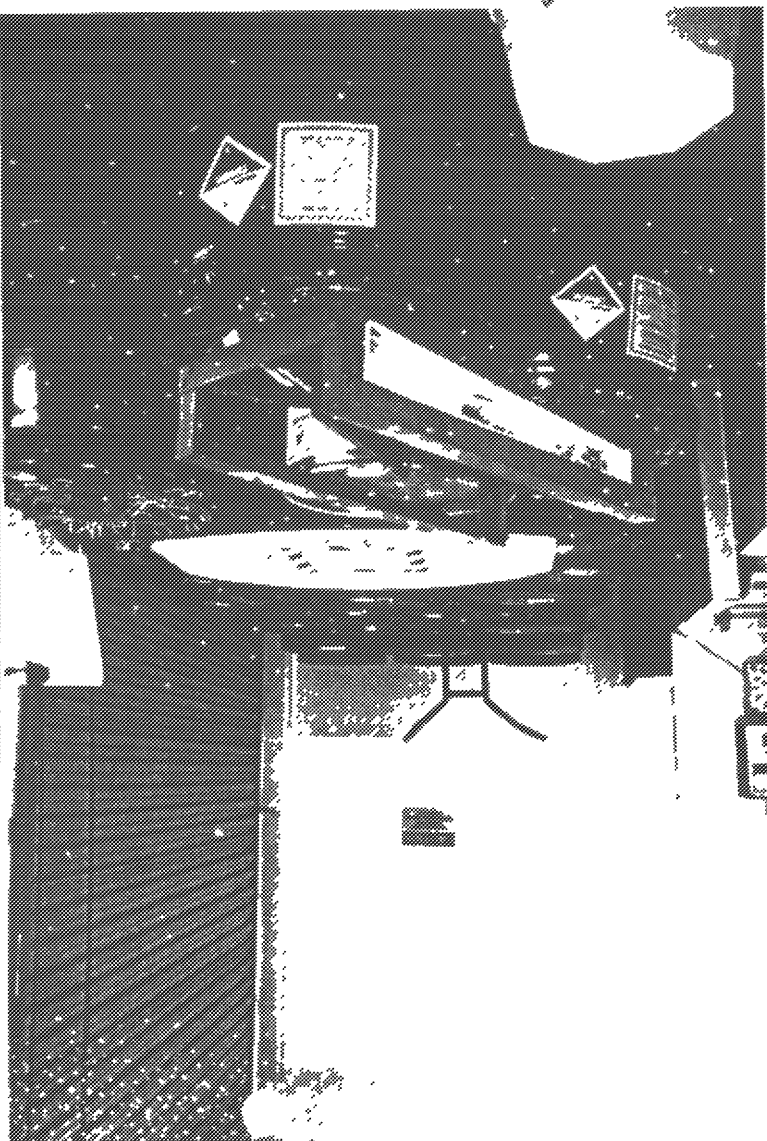
Hazardous waste from the entire facility accumulates in 55-gallon drums in a sunken area with a 6" berm in the Plating Room (see photos 11, 12, and 13). The berms are made of redwood, bolted and sealed into the concrete floor sealed with tar. Three bays separate acids (6' x 9'), caustics (6' x 9') and oxidizers (4' x 9').

The hazardous waste containers in the drum storage area do not have the accumulation date visible for inspection (see Photos 11-13).

Three views of Sunken
drum storage
area with
23 drums -
three of which
are empty
and one with
a product
The basketball
equipment
was not there
on 6/30/89.

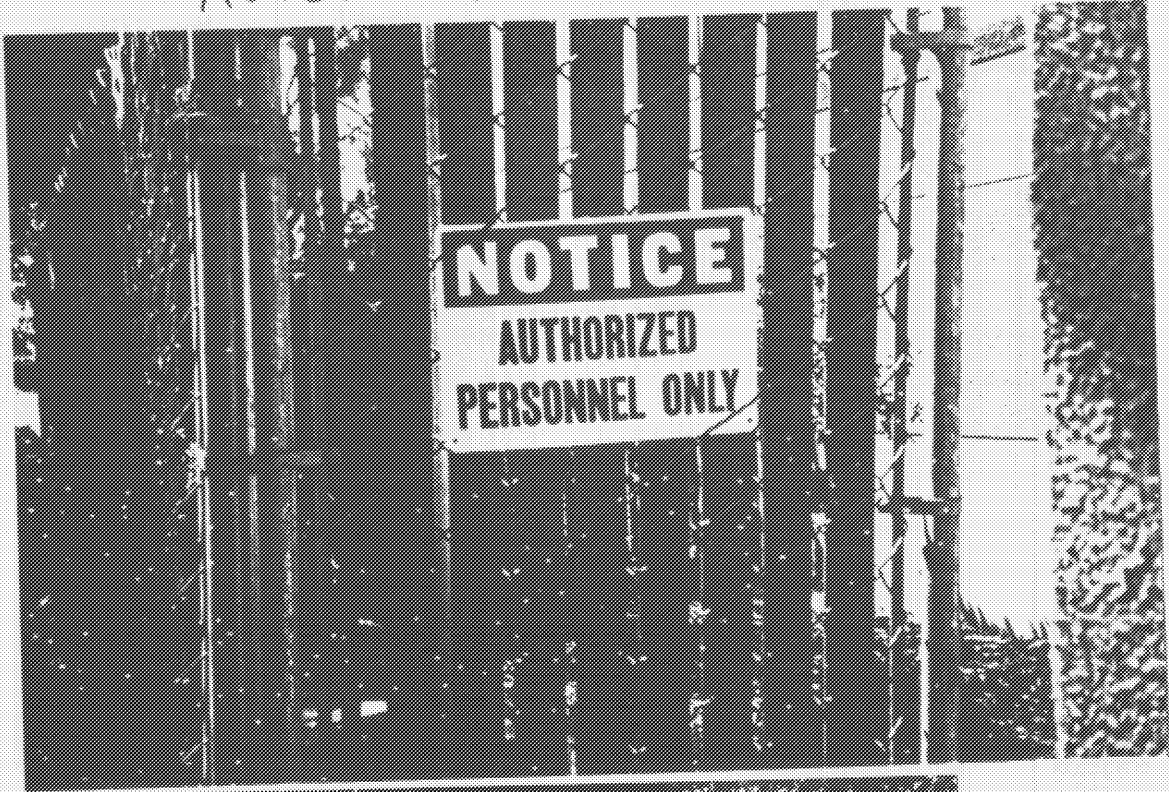
The neutralization sumps that treat acidic waste accumulates a copper sludge. The sumps are not labeled with the words, "Hazardous Waste" (see photos 14-16).

Photo 14:
Chain-link
fence to
Neutralization
sumps

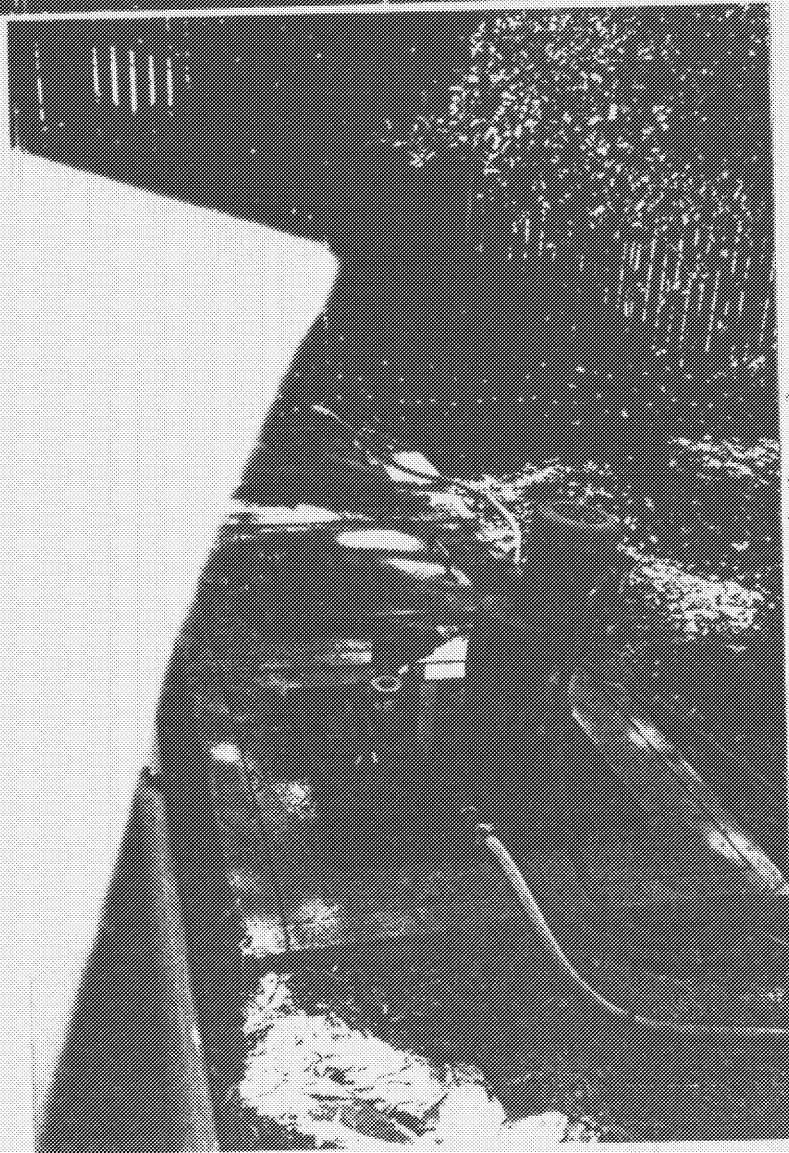
Photo 15:
3-Bay Neutralization
sumps. Waste enters
into sump at the
bottom of this photo.
The agitator (large
device) mixes the
wastewater to facilitate
precipitation of Cu and
monitoring for pH. The
pH monitor is the small
probe. The third bay
also has a pH probe.
Neutralized wastewater
is discharged from the
system to the San Joaquin
water District (POTW).
The agitator was on
at this time and
NaOH.

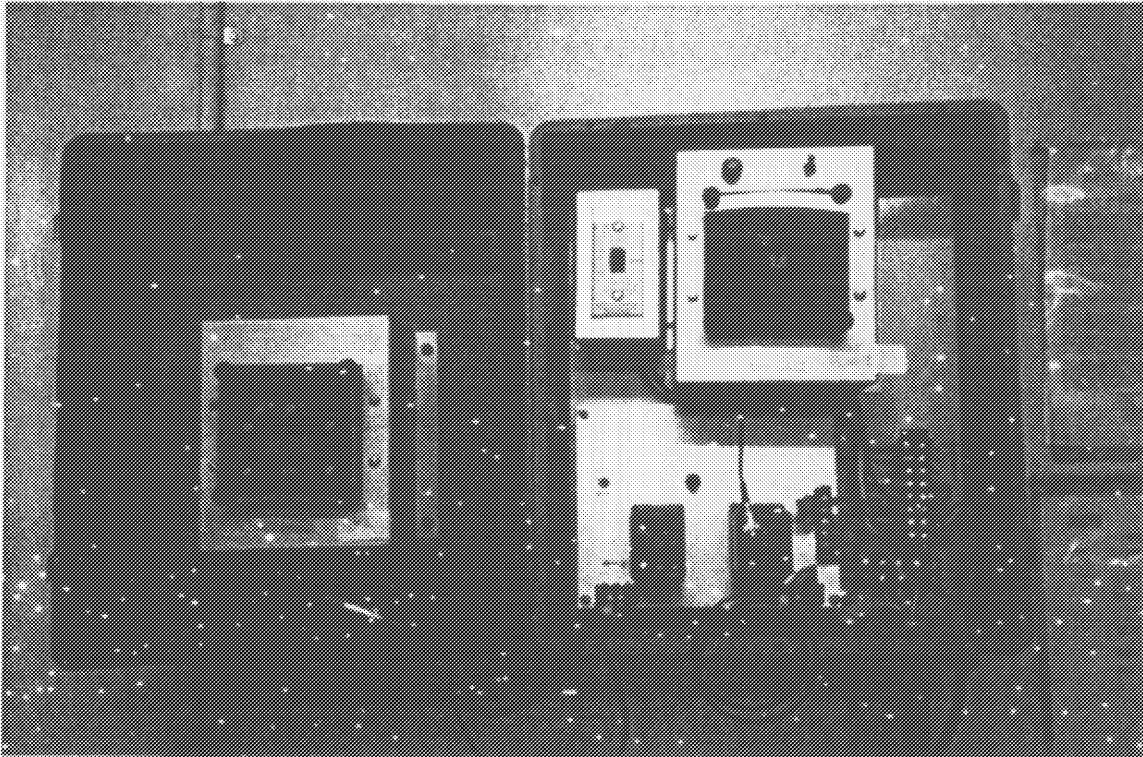
Photo 16: pH monitors for the neutralization sumps inside the Dry Film Room. The monitor on the right is the final pH (7.5) and the monitor on the ~~right~~ left is the initial pH (6.17).

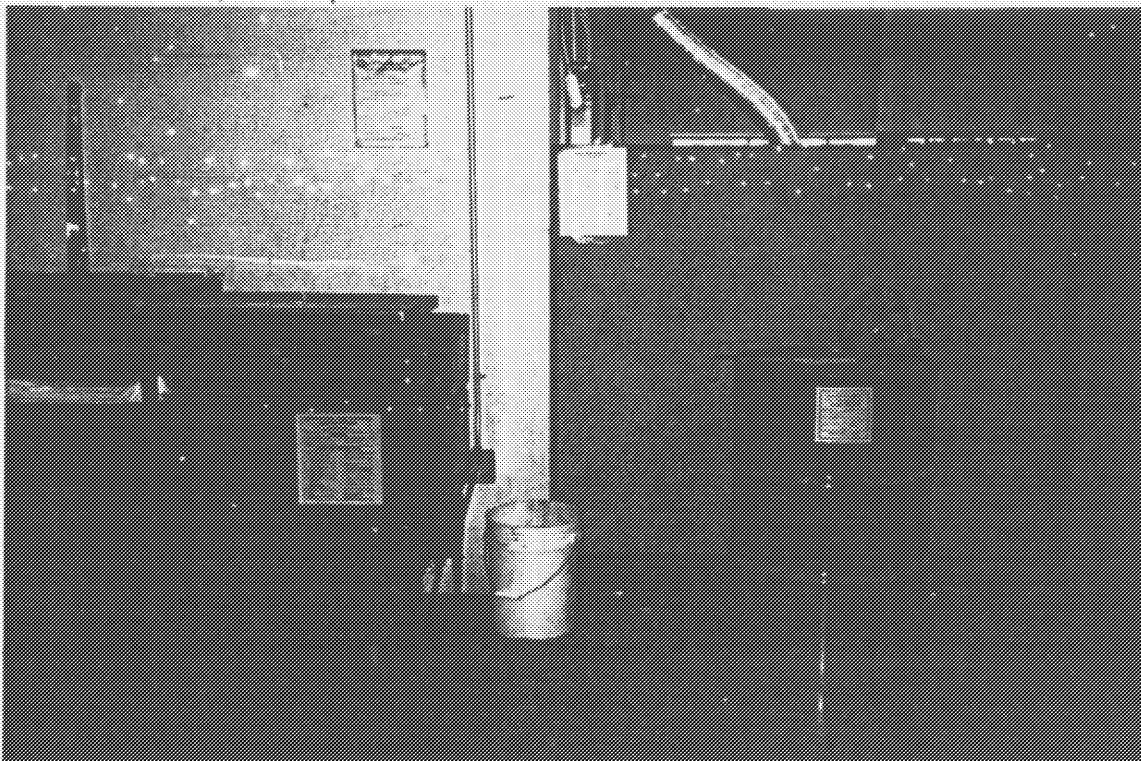
Photo 17: Vapor degreaser machine on the left and spent freon on the right in the Machine Shop Area.

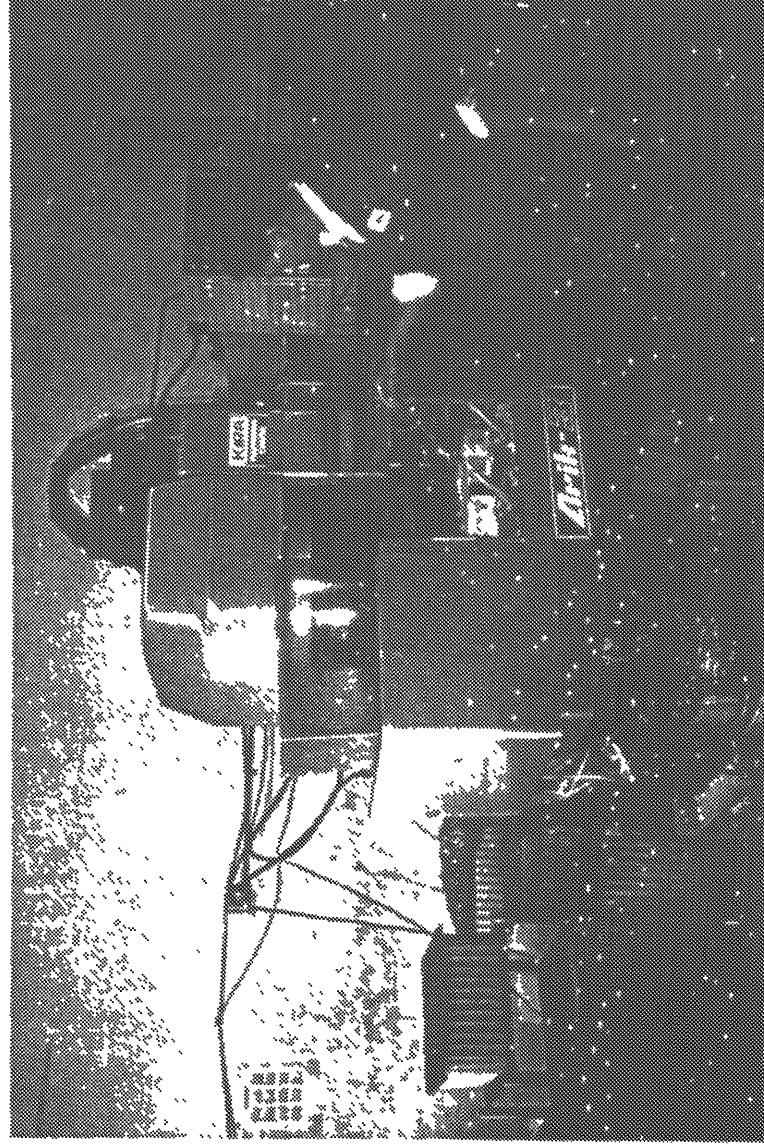
Photo 18: Aluminum parts cleaning machine. Note aluminum chips in plastic tubs and metal trash cans.

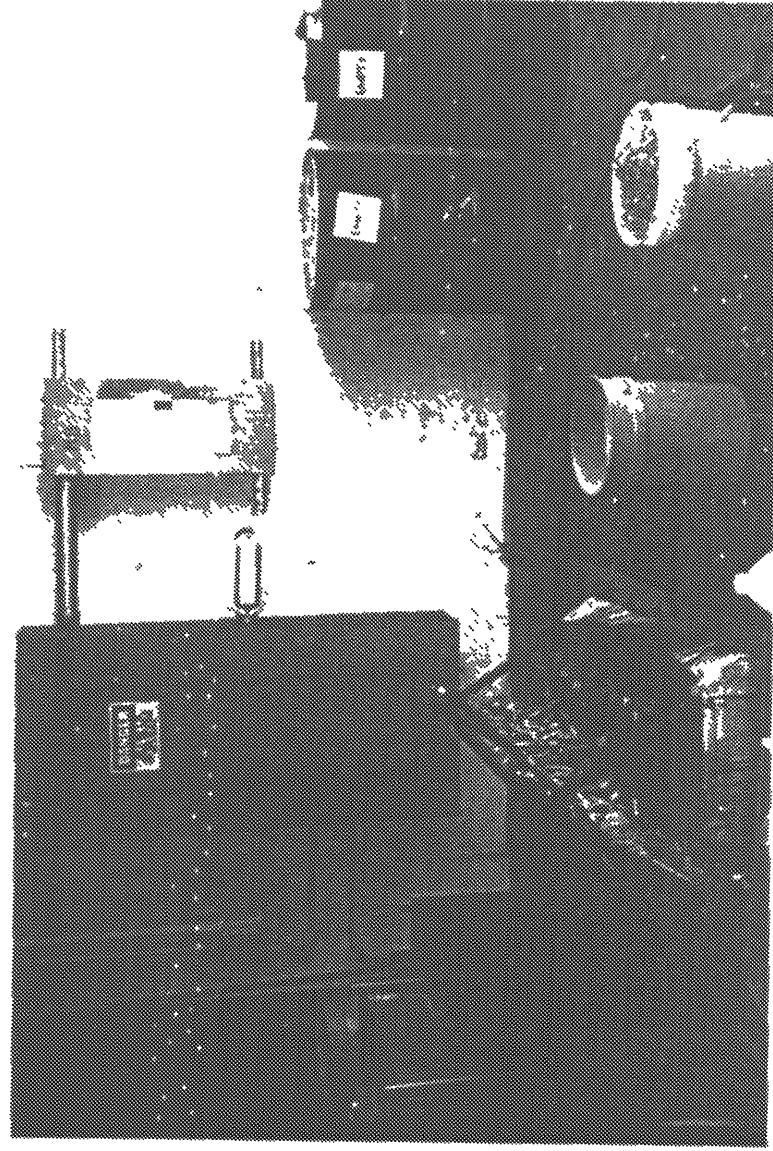
Photo 19: Non-hazardous resin-filled cardboard box with machine parts ranging in the Machine Shop Room. Empty pressure hot oil drums to be returned for deposit.
